Manhole Inspection Summary

Manhole # S25EE1036MH

Insp Date: **1/23/07 10:12 AM**

Location Address: **3940 HICKORY AVE**

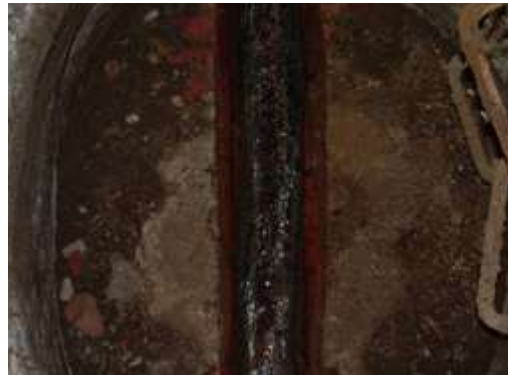
Top View

Bench debris. Corroded steps.

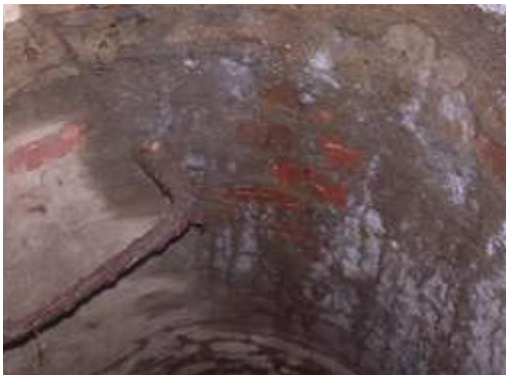
Defect

Adjustment and Barrel infiltration.

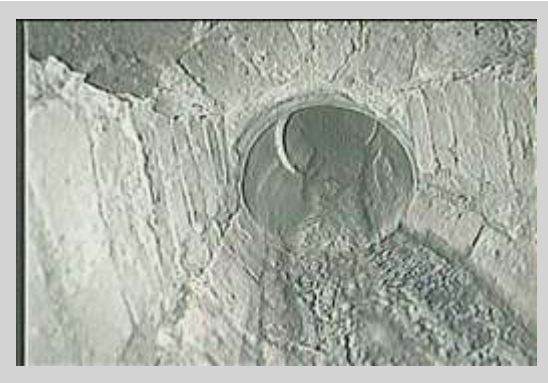
Pipe Out @ 12 O'Clock

Channel deterioration.

Infiltration: **Evidence** Pipe Seal Cond: **Unknown**
